# Shore & Beach

VOLUME 76 • NO. 4 • FALL 2008

## **Island Repair in the Maldives**

### **ABSTRACT**

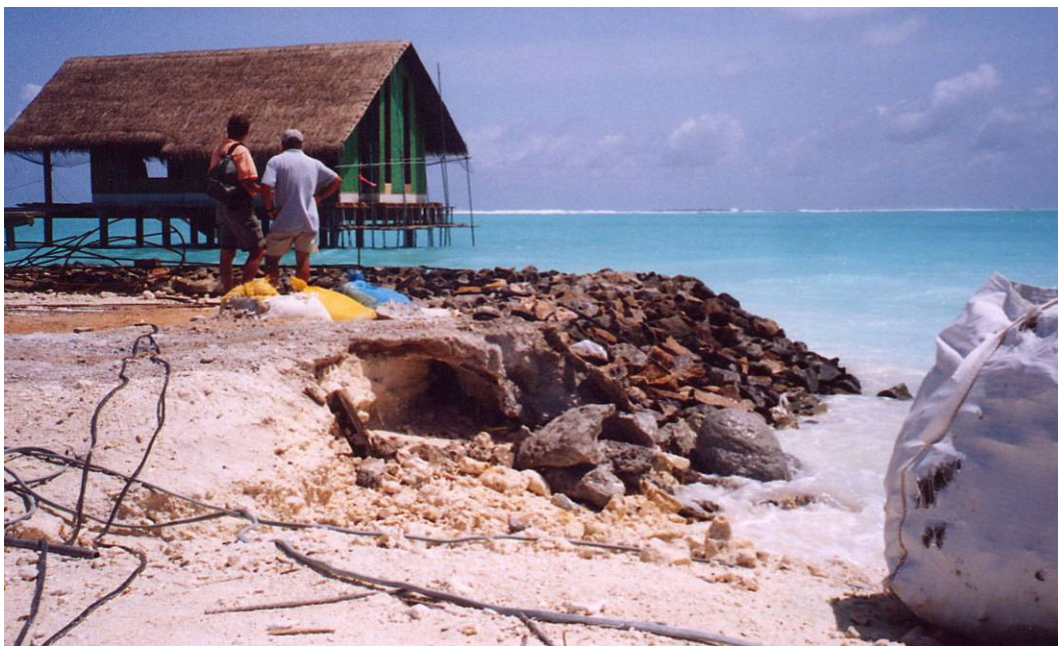
Upon my eventual arrival at the site, I found a fancifully shaped, 2-kilometer long island along which all of the sand shorelines were rapidly eroding (Figure 1). There were extensive areas of wave overwash and of poor water circulation, the latter being characterized by algae, silt and stagnation in the island's embayments. Most of the infrastructure, foundations and framing for the new resort facilities and its 200+ villas were already in place or under construction. Many of the structures were being undermined by the failing beaches (Figure 2). The client asked if we might "fix" the problem – adding that this unique luxury resort was scheduled to open in only six months.

**Figure 2. Typical shoreline conditions upon initial arrival at site.**

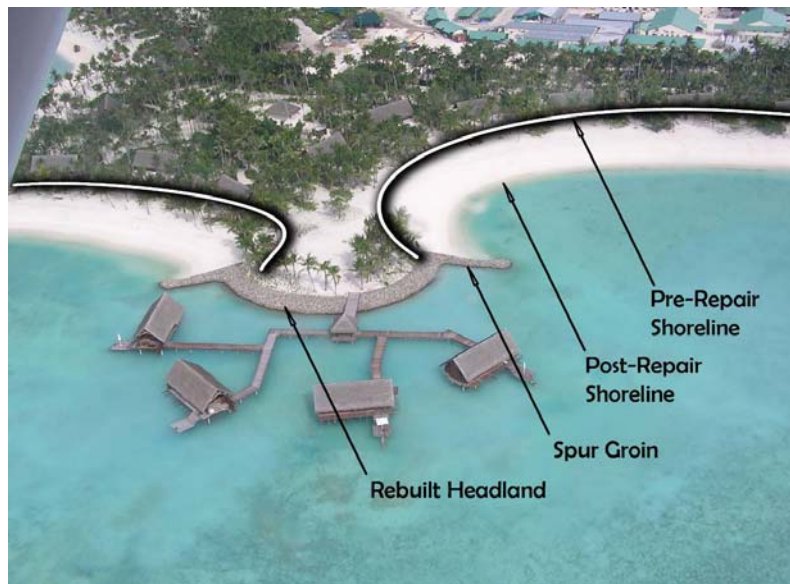
**Figure 4. Spur groins were added to the ends of existing headlands to stabilize the adjacent bay beaches.**

Between the existing rock-rubble headlands, the placed shoreline had predictably eroded as a vertical scarp, often right up to the villas. At these locations, we added spur groins to the existing headlands to "pull" the shoreline further seaward (Figure 4). The spurs, each about 28-m long and oriented to clear the existing over-water villas, resulted in an unusual structure shape, but one which was ultimately successful in stabilizing the shoreline at its intended location (Figure 5).

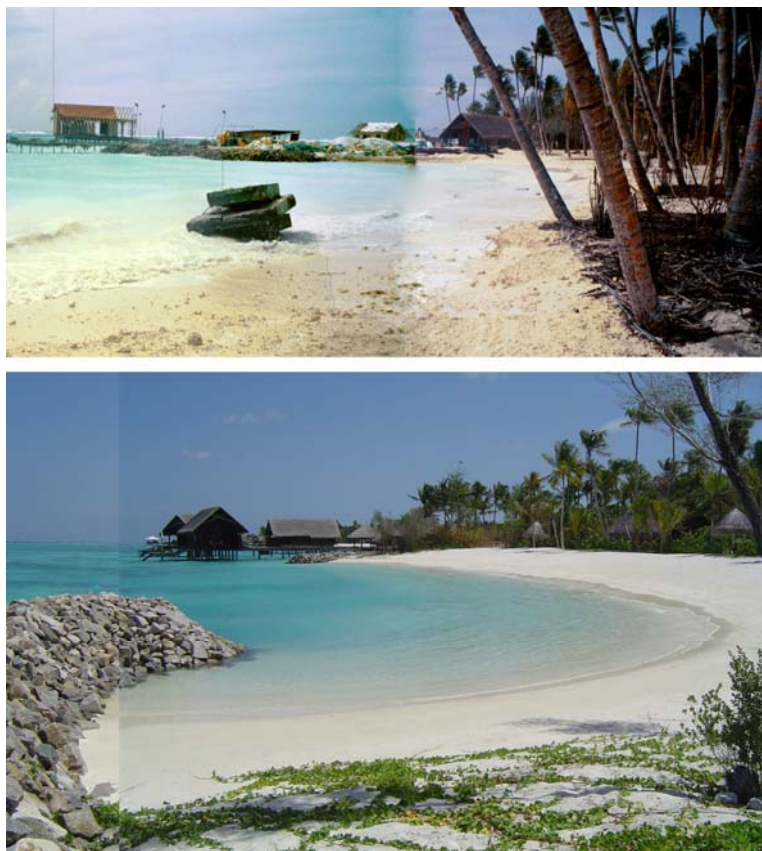
**Figure 5. Beach improvements after addition of spur groin at end of headland (upper: pre-repair; lower: several months post-repair).**

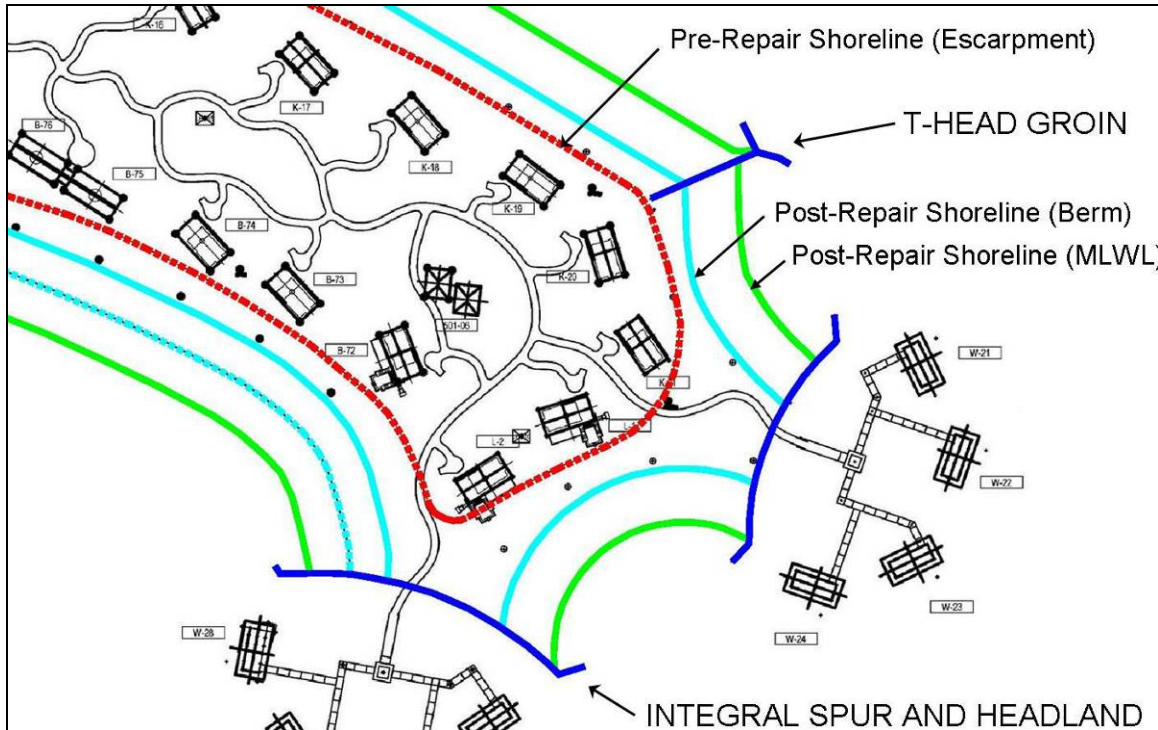
**Figure 6. Combined headland-spur groin structures, with T-head groin.**

Where the headlands were not yet built, an alternative headland design was introduced that integrated the spur-groins at its ends. The result is a broad concave structure (in lieu of the masterplan's original, short convex structures), often tied to an opposing T-head groin where a convex break in shoreline orientation was required (Figure 6).

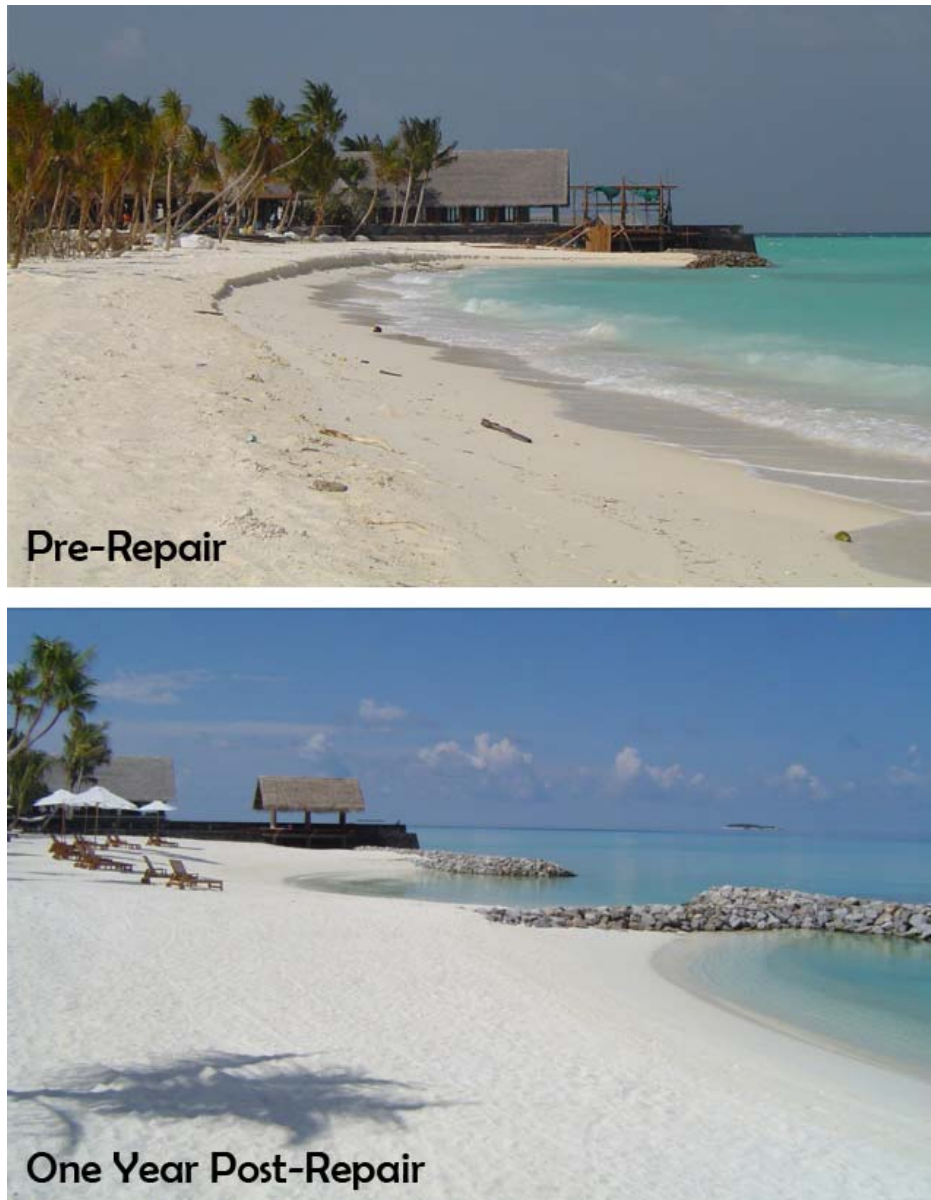
**Figure 7. T-head groins (lower photo) used to stabilize eroding beach near the resort lodge (upper photo).**

T-head groins were used to create smaller pocket beaches wherever practical, owing to their generally stable and predictable behavior (Figure 7). The additional stabilization afforded by these structures was particularly critical along the chronically erosive, higher-energy shorelines, typically located within a few hundred meters from the fringing reef. The lay-out design of the T-heads and pocket beach geometries followed a simple empirical predicate developed from prior experience (Bodge 2003). It presumes that the mean low waterline (MLWL) is located a fraction  $\gamma$  of the gap distance between heads, where  $1/3 < \gamma < 2/3$  and in the present case taken as about 0.4. The berm shoreline is located behind the MLWL as a function of the inter-tidal beach slope. The predicted berm shoreline must lie at least several meters seaward of the prescribed (design) berm, including setbacks (Figure 8). If it does not, the gap is narrowed, the groins are lengthened, the setbacks are reduced, or all three, in an iterative design process.

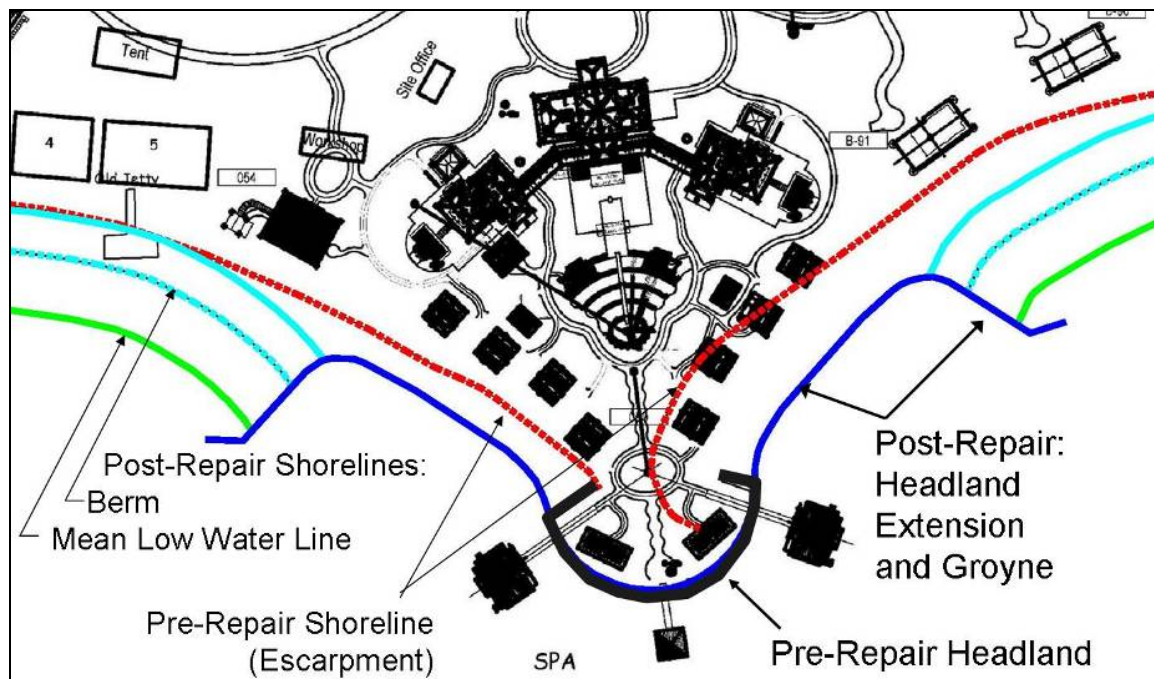
**Figure 10. Alongshore extension of headland and addition of groins to terminate the beach at a promontory where beach creation was infeasible.**

In locations where a beach was impractical due to insufficient space or set-backs, the headland had to be extended to armor the shore until the location at which a beach could be developed. An example is illustrated in Figure 10 at the resort's spa location. Other examples are illustrated in Bodge and Howard (2006).

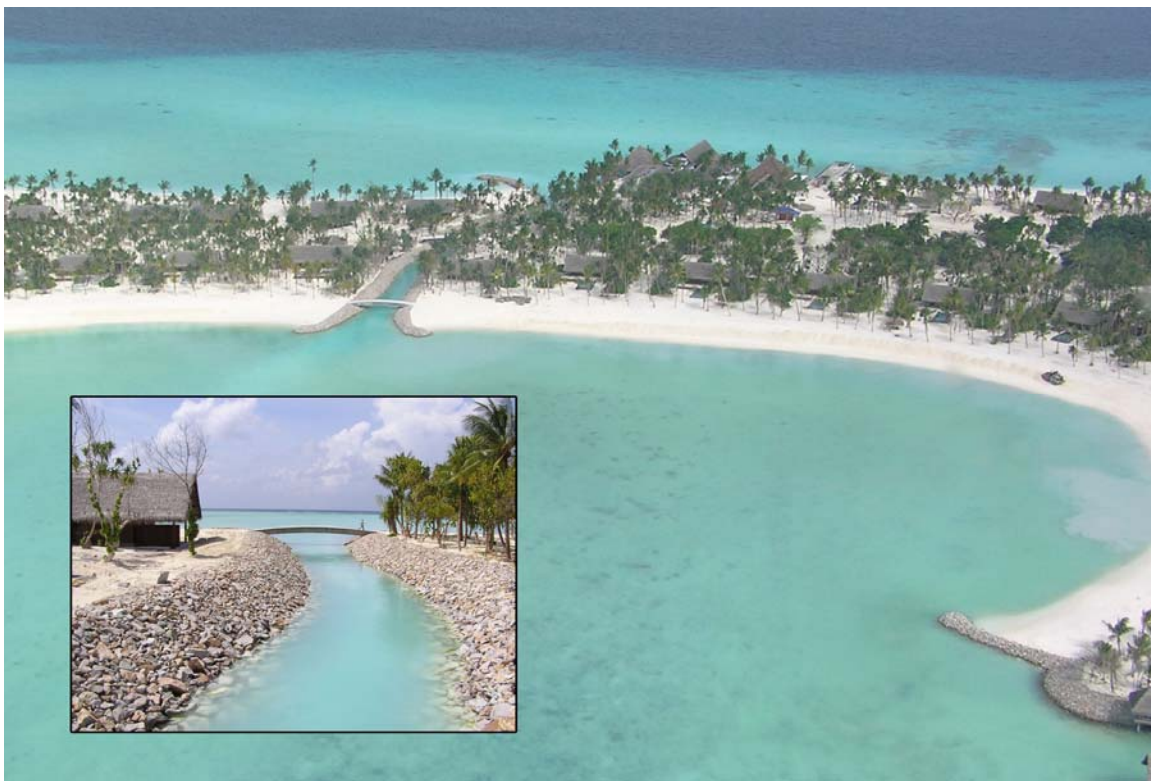
**Figure 12. Channel cut through the island (center left and inset), with spur groin and headland (far right).**

The channel was constructed as designed, and subsequent dye-tests proved the predictions correct (Figure 12). During a test on a rising spring tide that autumn, the estimated 66-second tidal lag should have created an easterly-directed 14 cm/s flow. Even with stiff 12 knot easterly winds from the winter monsoon, the channel flowed east – against the wind – at 40 cm/seconds, driven by the tide, as predicted. The typically high velocities appeared to have mostly obviated the potential problem of sedimentation along the channel and at the entrances.
