# Shore & Beach

VOLUME 76 • NO. 4 • FALL 2008

## **Island Repair in the Maldives**

### **ABSTRACT**

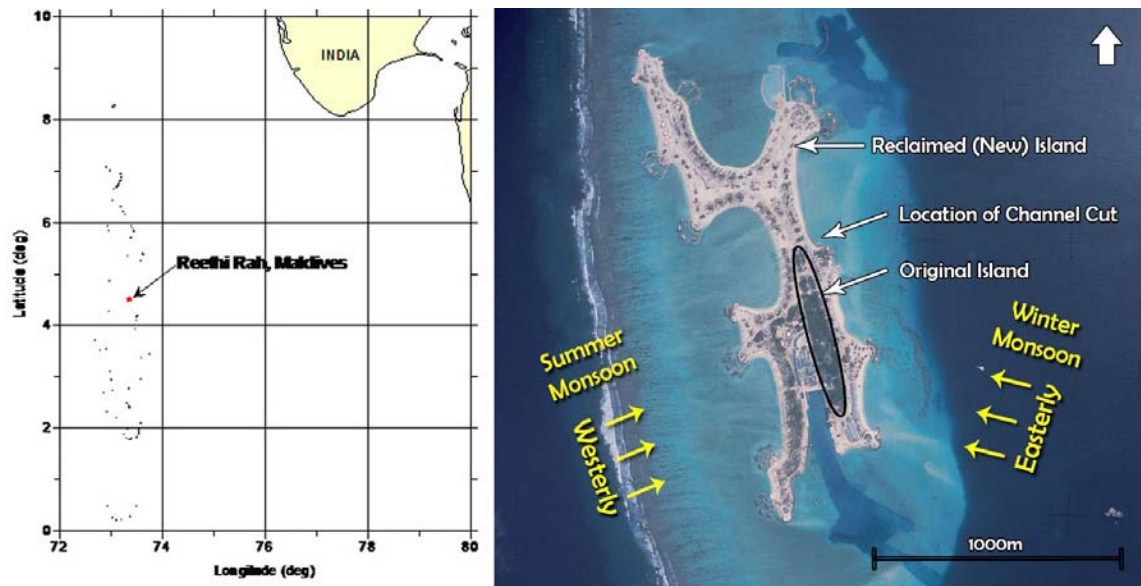
Upon my eventual arrival at the site, I found a fancifully shaped, 2-kilometer long island along which all of the sand shorelines were rapidly eroding (Figure 1). There were extensive areas of wave overwash and of poor water circulation, the latter being characterized by algae, silt and stagnation in the island's embayments. Most of the infrastructure, foundations and framing for the new resort facilities and its 200+ villas were already in place or under construction. Many of the structures were being undermined by the failing beaches (Figure 2). The client asked if we might "fix" the problem – adding that this unique luxury resort was scheduled to open in only six months.

**Figure 1. Location map and aerial view of the island (in construction).**

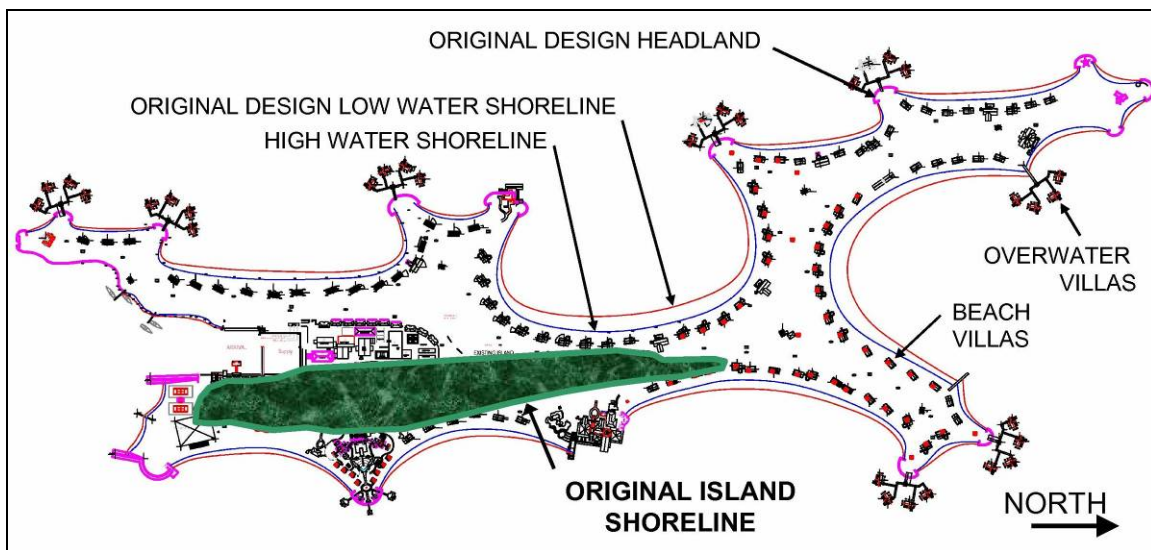
The basic problem was simple. Using locally dredged material, the island had been more than tripled in size and lengthened from about 1000 m to 1900 m. It was shaped in an unnatural geometry that bore no resemblance to the original or local islands, and which created large, poorly-flushing embayments. The layout was from the project Architect's original masterplan (Figure 3). The plan sought to maximize shoreline frontage and minimize set-backs between the assumed shorelines and the villas. It also violated fundamental principles in coastal design and engineering. For example, the indicated width between the design high-tide and low-tide shorelines varied around the island; and this width converged to zero at the beach's rock headlands. There, the design shorelines were drawn evenly with the face of the headlands (instead of being set-back from the headlands as dictated by typical beach geometry). The infrastructure and foundations for the resort facilities and villas were located relative to these imagined shorelines; and as the shorelines retreated to their more physically realistic location, the structures became quickly imperiled. From this initial visit, we concluded that the requisite reparations would add a couple of millions of dollars (US) and months to the schedule; and the work would have to be designed and built immediately, without luxury of formal studies or surveys.

**Figure 3. Original island and architectural master plan for new island.**

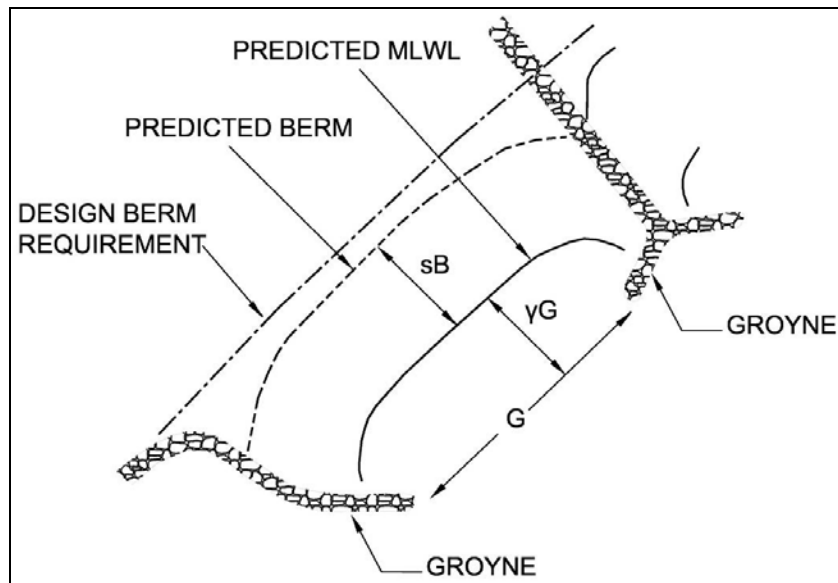
**Figure 8. Beach geometry between two groins (plan view).**

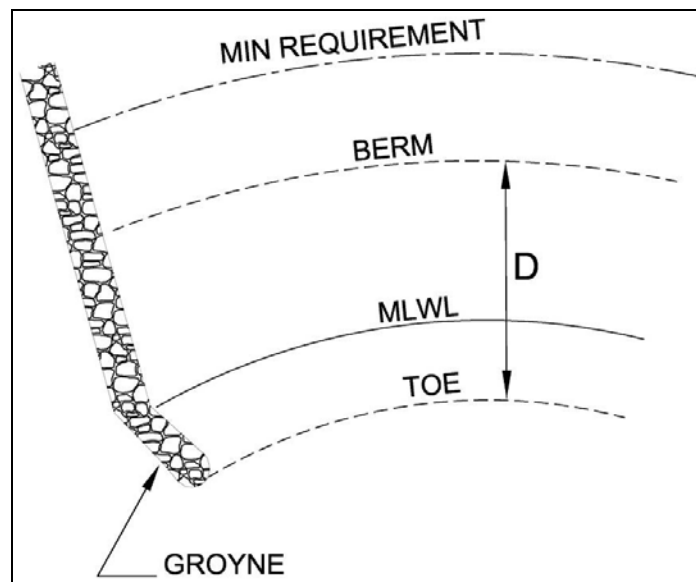
**Figure 9. Beach geometry adjacent to single groin (plan view).**

Where a single groin was used, such as at the terminus of a beach strand, another simple “in-house” design predicate was used. The beach elevation at the seaward end (toe) of the groin is presumed to be equal to one-half the tide range below mean low water (or, alternately stated, one tide range below mean sea level). The corresponding location of the berm is the slope-distance  $D$  above and behind this “toe” elevation (Figure 9). At this site, for a tide range of 1.4 m, the beach elevation at the groin’s end is predicted at -1.4 m MSL. The berm elevation, +1.5 m MSL, is located 2.9 m above this level at a typical

slope of 1:12. Thus, the berm location is predicted to be  $D = 2.9 \times 12 = 34.8$  m from the groin's end. If the predicted berm is too far landward, then the groin must be lengthened or other modifications made.

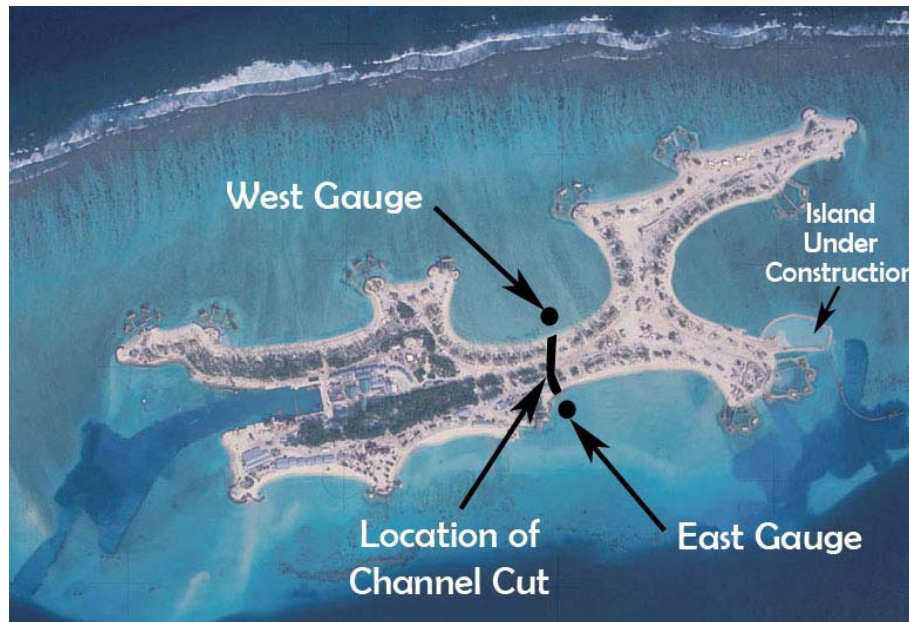
Another principal objective was to improve water quality, particularly in the largest embayment on the island's western side. Here, algae growth and cloudy water was prevalent in the calms between monsoon seasons. Buried culverts to connect opposite shorelines were ruled out because of the shallow depths, limited flows, and requisite outfall structures. Instead, at the base of the bay, near the northern end of the original island, we found a strip of land between villas that would be just barely wide enough to cut a channel across the island and connect two opposite bays (Figure 11). The open

**Figure 11. Locations of tide gauges and new channel cut across island.**

channel would be 14 m wide and 200 m long, and it would exit along the main lodge as a water feature, with entrance groins along the adjacent beaches. But it would sever the existing utility trunks, require two unanticipated bridges, and impact operations.
